Long Term test Burn of switch-grass co-fired with coal at OGS.

Corrosion and deposit tests.

Doc. no. 277766
Project no. T012618.12

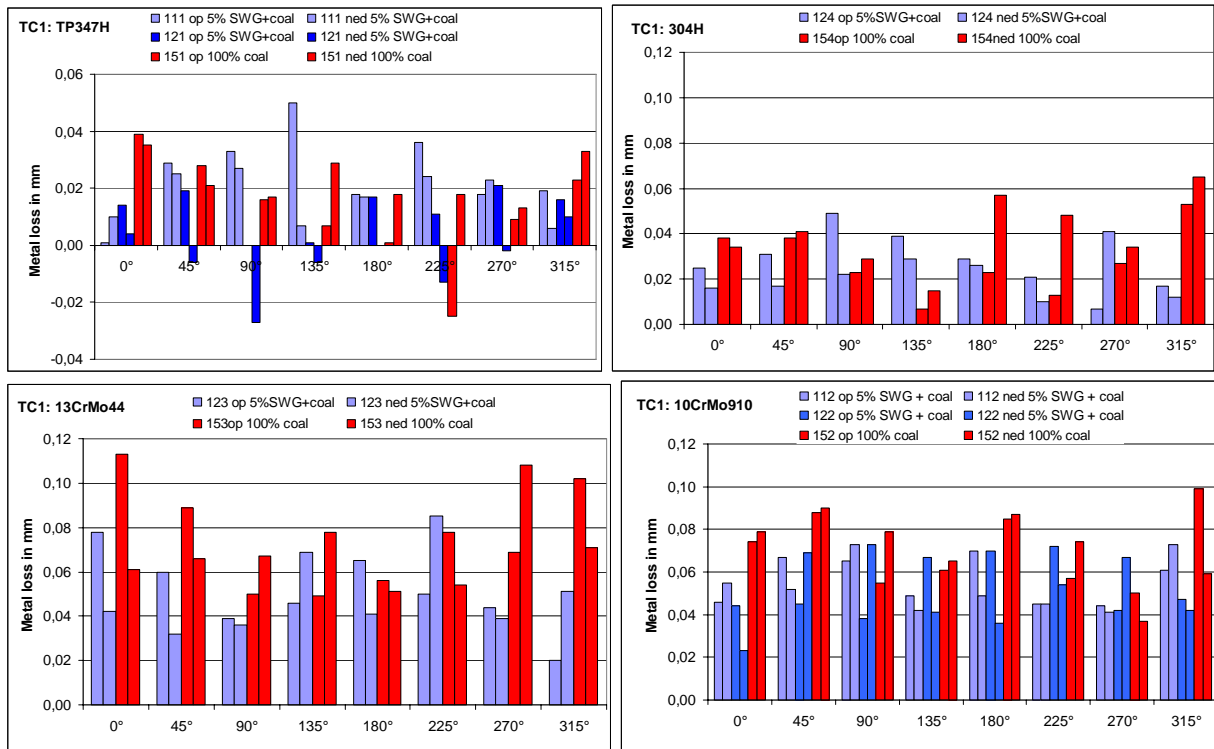
Figure 4: Metal losses determined for corrosion coupons in position TC1.

Generally, it appears from Figure 4, Figure 5 and Figure 6 that similar metal losses are experienced during SWG co-firing and 100% coal firing taking the experimental uncertainty into consideration. Thus, there is no evidence of increased corrosion rates during 5 %-wt. SWG co-firing.

It is also seen in Figure 4, Figure 5 and Figure 6 that the measured metal losses are relatively similar at both ends of the test coupons, i.e. specimens denoted "op" (steam inlet) and "ned" (steam outlet).

It is clearly seen in Table 15 that the two ferritic steels show consistently higher metal losses than the two austenitic steels. Even though the worst average is considered, no greater metal loss than 0.05 mm i.e. 0.15 mm/year has been observed for the austenitic steels in the co-firing case. For the ferritic materials, metal losses of up to 0.22 mm, i.e. 0.66 mm/year are measured during co-firing. The corrosion rates measured for the austenitic materials are fully within the acceptable range whereas for the ferritic materials they are higher than acceptable.

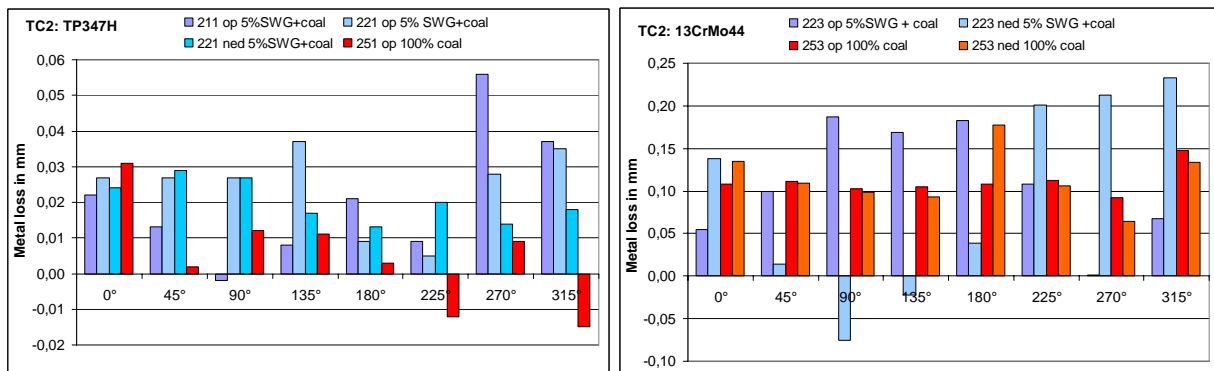
Figure 5: Metal losses determined for corrosion coupons in position TC2.

With respect to the position in the boiler, Table 15 indicates that for the ferritic steels, the highest metal losses are observed in position TC2, the superheater finishing region. For the austenitic materials no distinctive influence on position can be observed. TC2 is the position with the lowest flue gas temperature. The influence of position will be further discussed below.

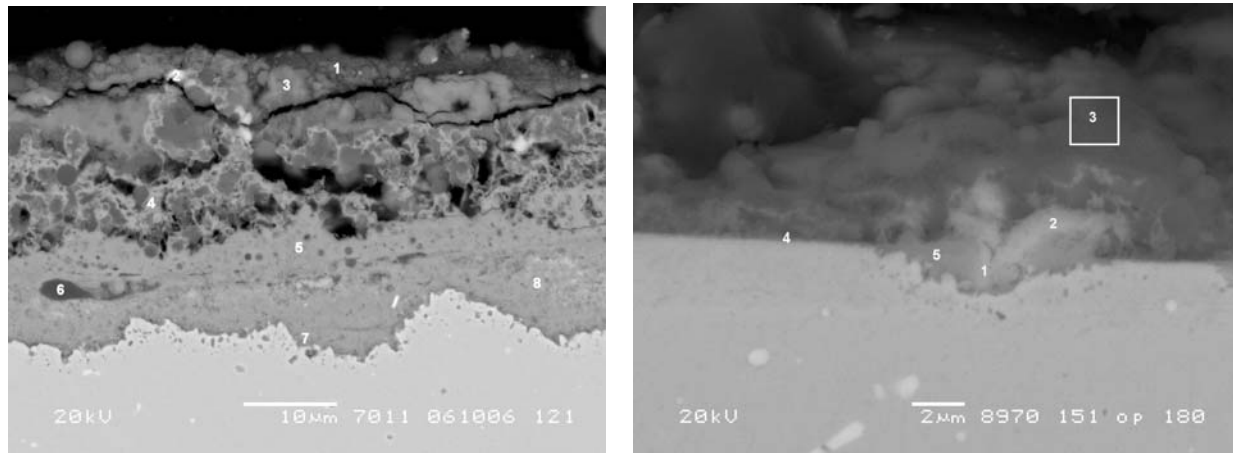
Figure 7: SEM images of inner oxide layer for test specimen of TP347H located in position TC1. Left: SWG Co-firing. Right: 100% Coal.

SEM images of TP347H (the better material) and 13CrMo44 (the poorer material) steels at position TC1 for SWG co-firing and coal reference tests are shown in Figure 7 and Figure 8. It is clearly seen that a thinner oxide (2-10 μm) is formed for the TP347H than the 13CrMo44 steel (20-40 μm).

For both the co-firing and coal-firing cases (TP347H), the deposits adjacent to the oxide are mainly composed of Ca, Fe, O, and S ($\text{CaSO}_4 + \text{FeO} + \text{FeSO}_4$) as well as minor amounts of Al and Si (Al-silicates). No chlorine and only small amounts of potassium (1-2%) are observed within the deposit for the co-firing case. The TP347H oxide consists of an outer layer of Fe-oxide and an inner of Fe-Cr-Ni-oxide. Sulfur was also found within the inner oxide. This indicates that sulfur take actively part in the corrosion mechanism.

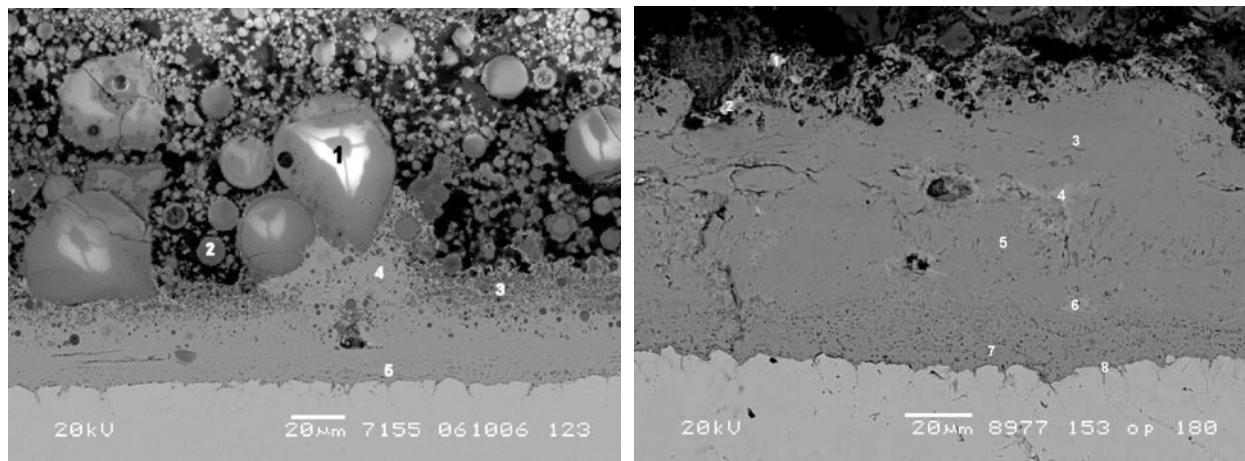
Figure 8: SEM images of inner oxide layer for test specimen of 13CrMo44 located in position TC1. Left: SWG Co-firing. Right: Coal reference.

For the 13CrMo44 co-firing specimen (Figure 8, left), particles rich in Mg-Ca-Al-Si are seen in the inner deposit. The oxide consist mainly of Fe-oxide but also some Ca and S. At the deposit-oxide interface (spot #3), minor amounts of potassium is also detected, i.e. mixed sulfates of K and Ca. No chlorine is detected. In the coal case, the oxide is similarly composed of Fe-oxide and smaller amounts of S.

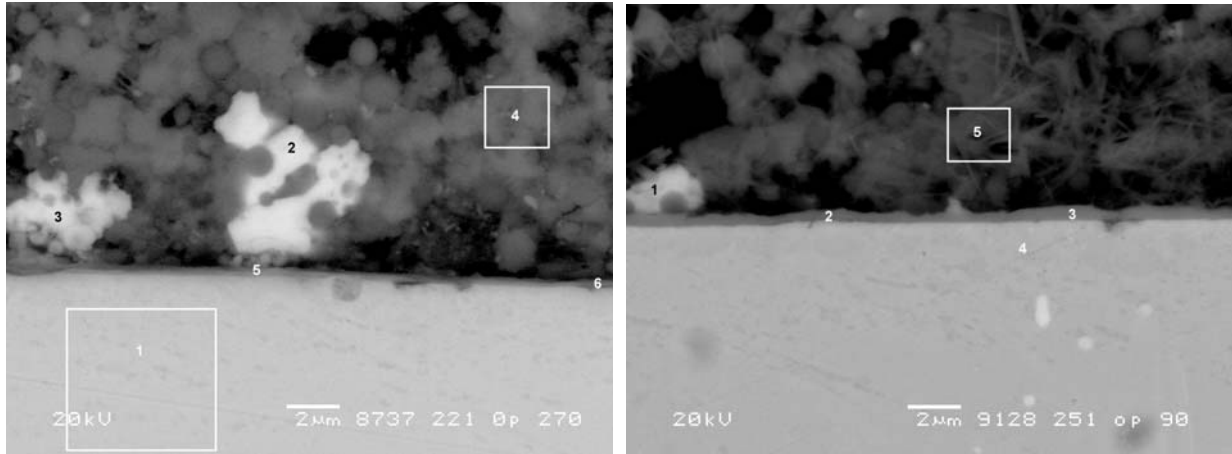
Figure 9: SEM images of inner oxide layer for test specimen of TP347H located in position TC2. Left: SWG Co-firing. Right: 100% Coal.

SEM micrographs of TP347H and 13CrMo44 test coupons exposed in position TC2 are shown in Figure 9 and Figure 10. As in the TC1 position, a very thin oxide (approx. 1 μm) are observed for the TP347H specimens and significantly thicker oxides (50-100 μm) for the 13CrMo44 specimens.

Figure 9, left indicates that the inner deposit of the TP347H co-firing specimen is mainly composed of CaSO_4 and Al-silicates. Also 1-5% of K is found together with Ca and S. The bright white particles (spot #2 and #3) that are seen in the SEM image consist of nearly pure BaSO_4 . The oxide is thin and rich in Cr. No chlorine is detected in the deposit or oxide. The deposit composition and texture of the coal reference specimen appear much similar. However for the coal specimen, the K content of the inner deposit is lower, but instead Na is detected together with Ca and S. The oxide is similarly thin and rich in Cr.

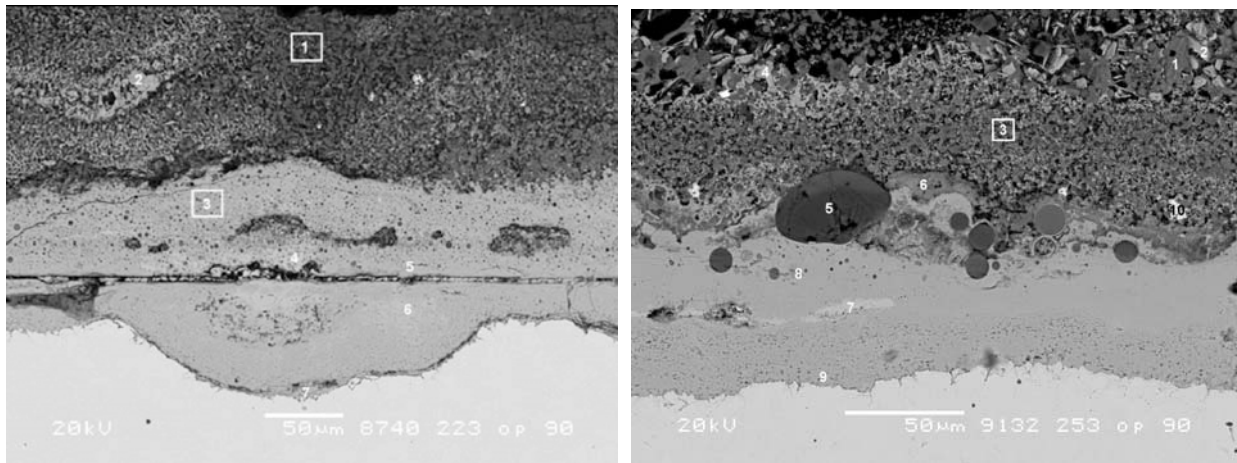
Figure 10: SEM images of inner oxide layer for test specimen of 13CrMo44 located in position TC2. Left: SWG Co-firing. Right: 100% Coal.

The inner deposit of the 13CrMo44 co-firing specimen (Figure 10, left) contains primarily CaSO_4 . The outer oxide layer contains elements from the deposit, Ca, S and Al whereas the inner oxide is mainly Fe-oxide and sulfur. The dark colored line that is seen dividing the oxide is composed of FeS and indicates the original metal surface. No chlorine is observed. In general, the inner deposit and oxide of the specimen from the coal reference test (Figure 10, right) are similar. Sulfur is also found within the inner oxide.

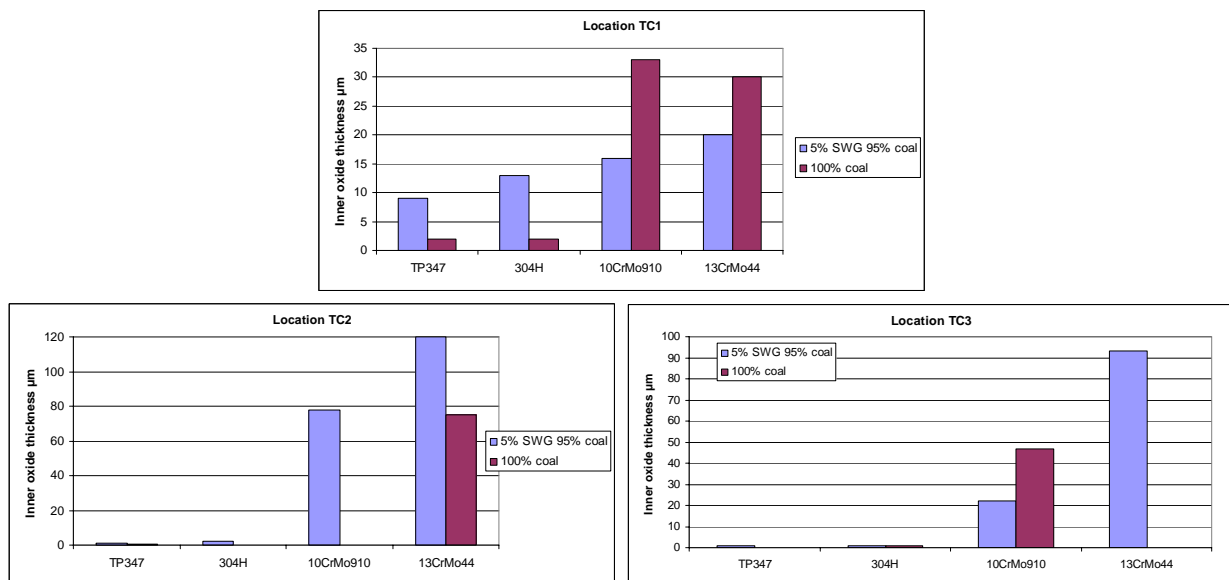
Figure 11: Thickness of inner fireside oxide for specimens at position TC1-TC3.

It is seen in Figure 11 that the oxide is much thicker for the ferritic than the austenitic materials. This is consistent with the higher metal losses measured for the ferritic steels as shown in Figure 4, Figure 5 and Figure 6 and Table 15. This is furthermore in agreement with the expectations as the thickness of the oxide typically increases with decreasing Cr content, i.e. 0.7-2.5 % for the ferritic and 17-20 % for the austenitic steels. It is also seen in Figure 11 that the oxide thickness for the ferritic steels spans from

30 µm in position TC1 to 90-120 µm in positions TC2 and TC3. This indicates higher corrosion rates at the latter positions although the flue gas temperature is much higher at position TC1 (1350°C) compared to that of TC2 and TC3 (900-950°C). This may be caused by the in general higher concentrations of soluble K and Na salts (primarily sulfates) in the deposits at positions TC2 and TC3. At position TC1, the relatively high flue gas temperature prevents condensation of alkali sulphates to a large extent. The oxide thickness for the austenitic materials is low at all positions.

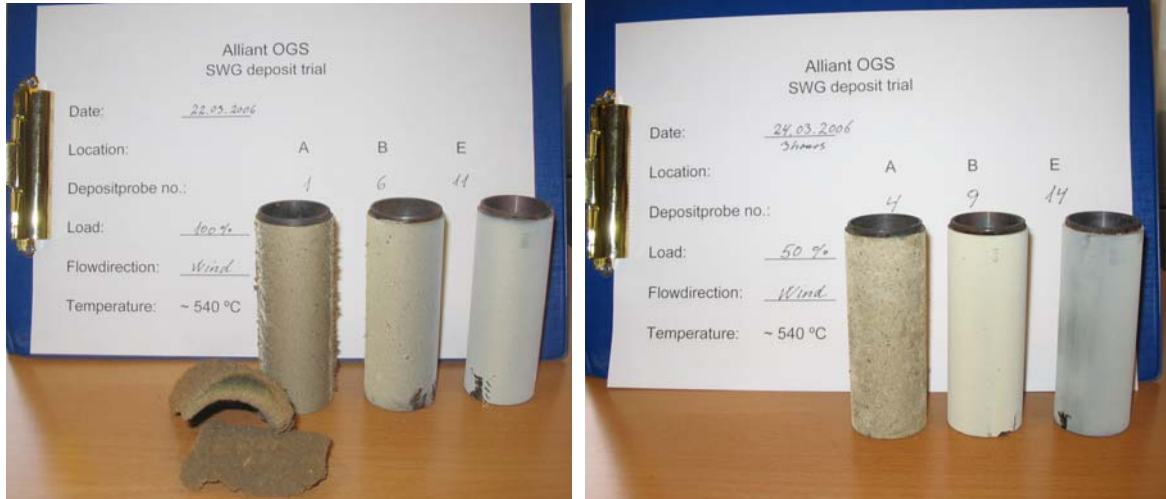
Figure 12: Deposit test rings after 3 hours' exposure. Left: Co-firing Test 1 - 100% load. Right: Co-firing Test 2 - 50% load.

In Figure 12, pictures of deposits obtained during SWG co-firing at 100 and 50% boiler load, respectively, are shown. The big deposit pieces, which are seen in front of test ring A (left picture) are recovered from the outer deposit layer (upstream side). These pieces detached during probe retraction. It is evident from Figure 12 that most material is deposited in position A followed by B and E. It is also clear

that more material is deposited during the test at 100% load despite the fact that the SWG share is lower during this test.

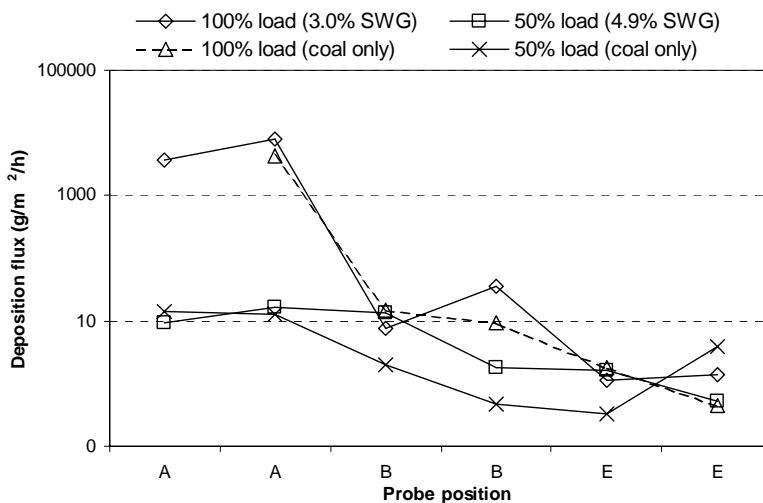
Figure 13: Measured deposition flux (upstream side) as a function of probe position.

Estimates of the deposition fluxes (upstream side) at positions A, B, and E can be derived from the deposit probe measurements, which are shown in Figure 13. As some of the deposited material was lost from the probe during retraction in most of the tests, the estimated values only provide an order of magnitude estimate. At position A, the deposition flux is very high (1-10 kg/m²/h) during full load but decreases substantially (10-20 g/m²/h), as the load is reduced. In position B, the deposition flux is much lower than at A at full load, but at 50% load the difference is less pronounced. In position E, the deposition flux is lower (0.5-6 g/m²/h) than at the other two positions. It is expected that locations further downstream are experiencing lower deposition fluxes, because the flue gas temperature is lower ($\approx 750\text{ }^{\circ}\text{C}$ at pos. E contra $\approx 1370\text{ }^{\circ}\text{C}$ at pos. A) and thereby the fly ashes have lower tendency to stick. Figure 13 furthermore reveals that SWG co-firing has no detectable influence on the deposition fluxes.

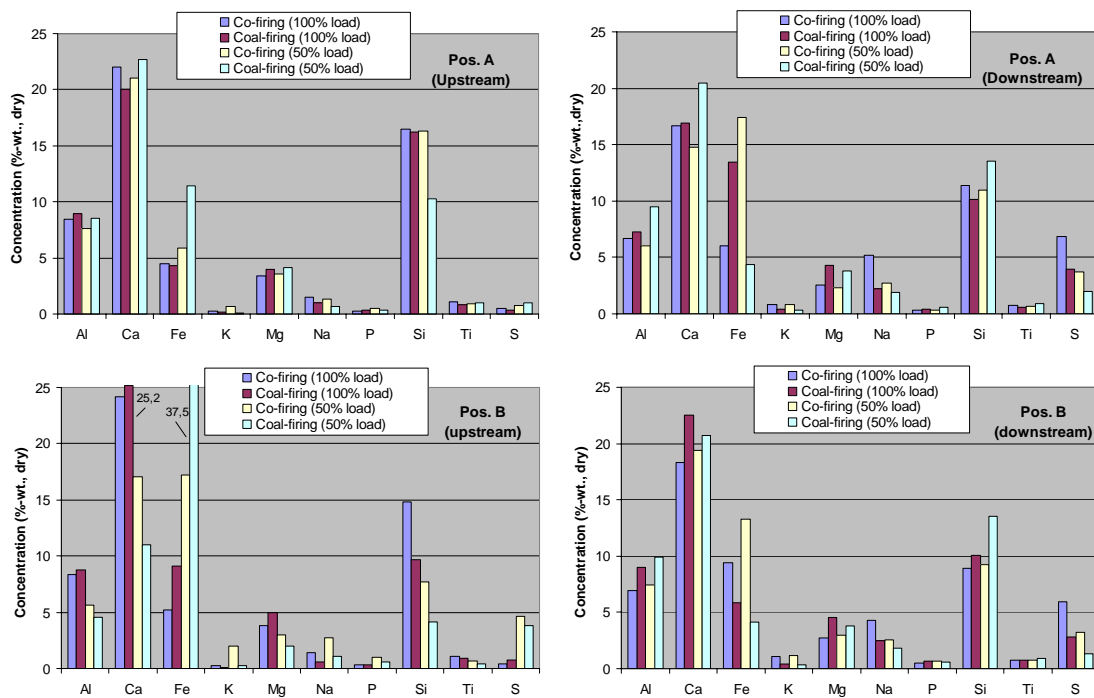
Figure 14: Elemental composition of deposit samples obtained during SWG co-firing and coal reference tests.

Generally, Figure 14 shows that the deposits collected during co-firing and 100% coal-firing as well as at 100 and 50% load (corresponding to 3.0 and 4.9 %-wt. SWG share, respectively) have very similar composition. The increase in potassium content caused by the increased SWG share is insignificant. Comparison of the upstream and downstream side of the deposits reveals that the downstream side contains higher levels of sodium and sulfur, i.e., sodium sulfate. This is as expected as the leeward side will be richer in flame-volatilized species and leaner in elements contained in entrained ash particles (non-volatile elements). The high iron content observed in some of the samples is most likely related to contamination of the deposit sample with iron from the metal test ring. This may artificially lower the concentration of the other elements.

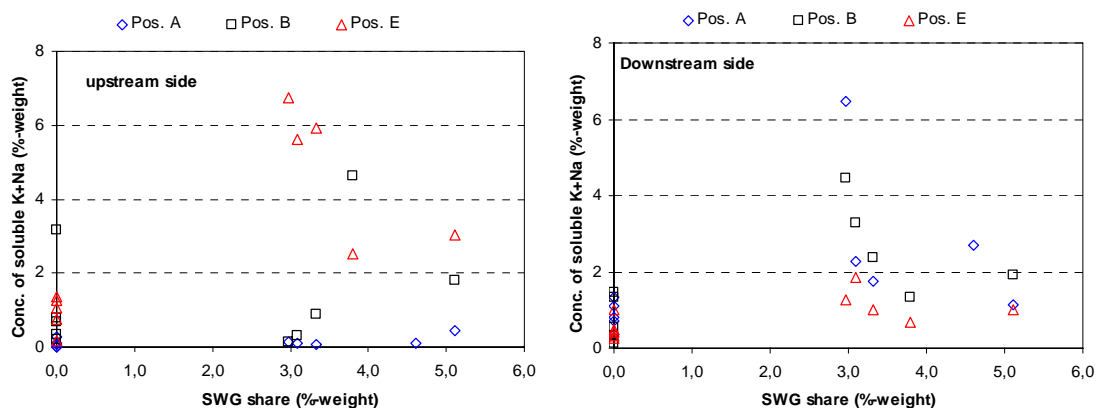
Figure 15: Concentration of soluble K+Na (%-wt.) in deposit from the upstream and downstream sides.

It appears from Figure 15 that there is no clear correlation between the SWG share and the concentration of water-soluble alkali in the deposits. This is probably related to the fact that even small variations in the alkali concentration of the coals causes greater change in the K and Na inputs than co-firing of up to 5 %-wt. SWG. In addition, as the SWG share was increased by decreasing the boiler load, the flue gas temperature will decrease at each probe position as well. This suggests that flame-volatilized species may condense further upstream at reduced boiler load, which is in agreement with the results in Figure 15.

On the upstream side, it is seen that the concentration of water-soluble alkali is very low for all tests at probe position A. For probe positions B and E, the concentration of soluble alkali is in most cases significantly higher. At probe position E, the concentration of soluble alkali appears to be higher for the co-firing tests than the coal reference tests.

For the downstream side, Figure 15 (right) indicates that there are small amounts of water-soluble alkali present in the deposits collected at all locations. This is probably related to the fact that the downstream side, to a higher extent, is composed of flame-volatilized material. The concentration of soluble alkali on the downstream side does not appear to increase with increasing SWG share.
