Deposit specimens exposed to 5% switchgrass + coal co-firing at Alliant, Iowa

**Melanie Montgomery
IPL/Vattenfall/Dong Energy
Technical University of Denmark**

**Jacob Knudsen
Dong Energy - Teglholmen**

19 April 2007

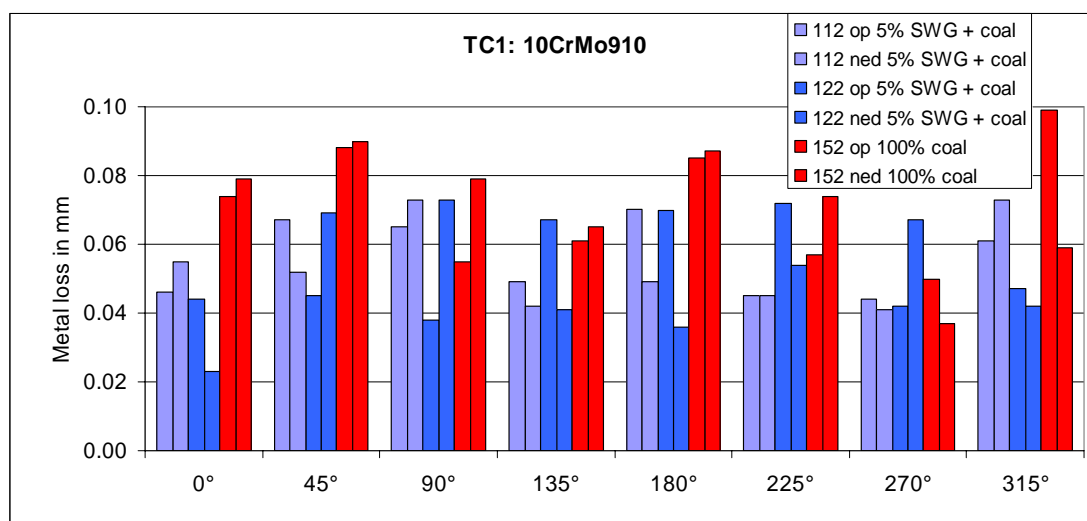
Figure 7: Metal loss measurements for 10CrMo910 exposed in TC1.

Figure 7 shows the metal loss thickness for 10CrMo910. According to this diagram, the metal loss in coal firing is similar to that in co-firing with switch grass.

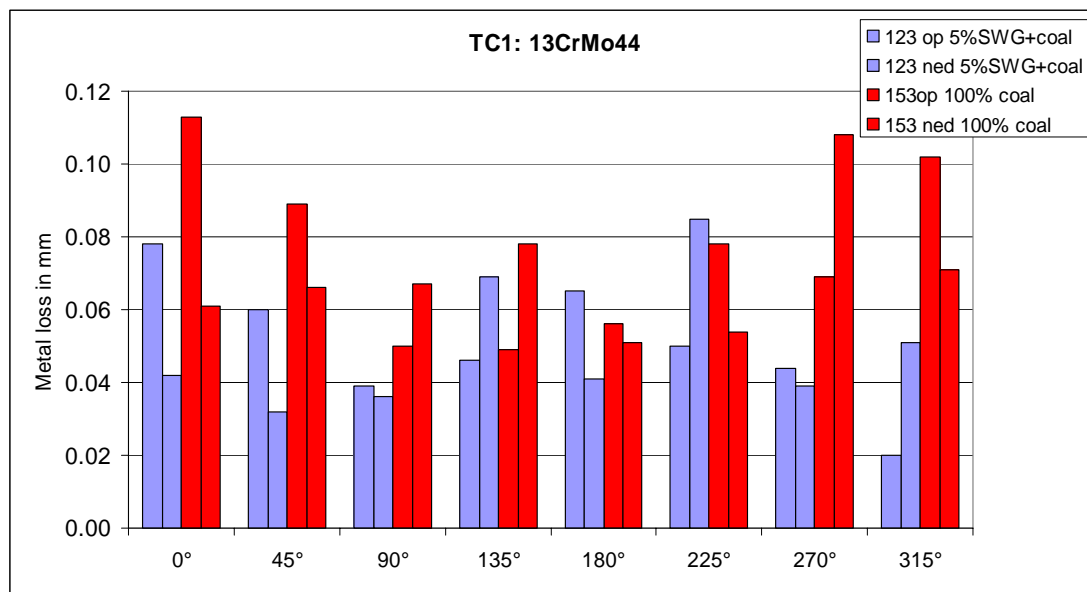
Figure 10: Metal loss measurements for 13CrMo44 exposed in TC1.

Figure 10 shows the metal loss thickness for 13CrMo44. According to this diagram, the metal loss in coal firing is slightly higher than that in co-firing with switch grass.

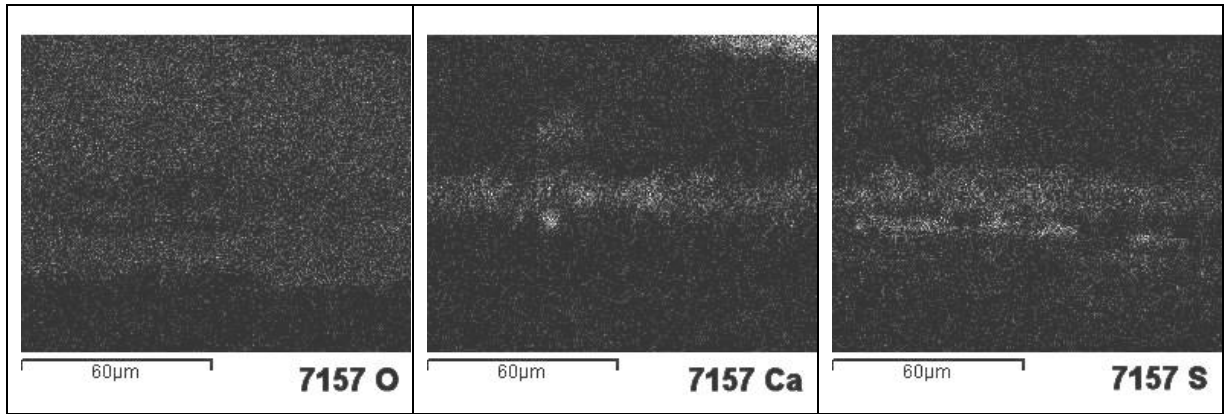
Figure 11: SEM-EDS analysis of 13CrMo44 (123 op) showing elemental distribution.

Specimen 123 op has an outer calcium, silicon, aluminium rich deposit. The corrosion products is predominantly iron oxide, however there is both calcium and sulphur detected within the outer oxide (Figure 11).

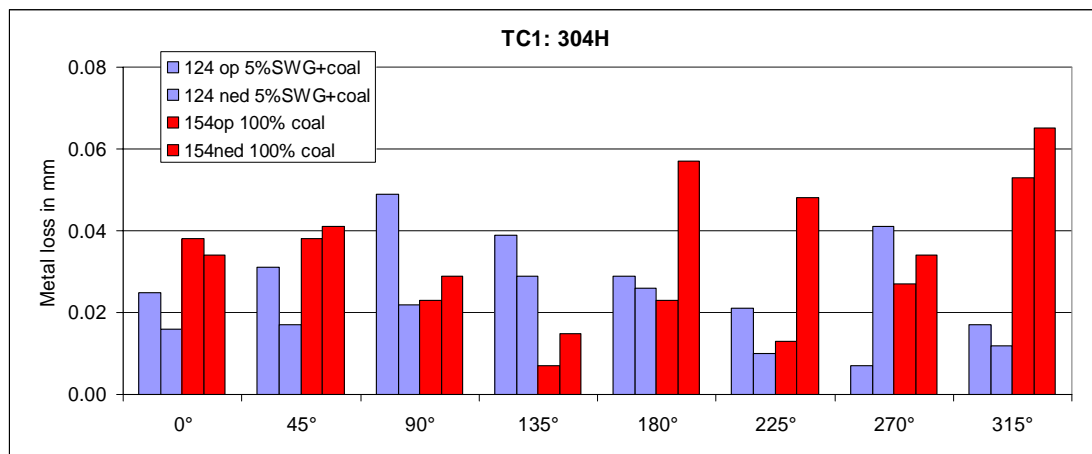
Figure 13: Metal loss measurements for 304H exposed in TC1.

Figure 13 shows the metal loss thickness for 304H. According to this diagram, the metal loss in coal firing is similar to that in co-firing with switchgrass.

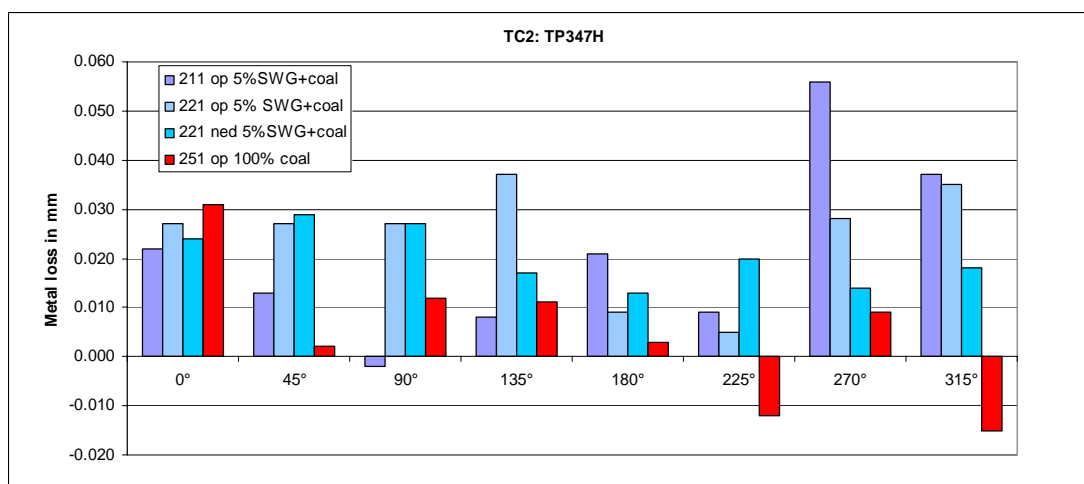
Figure 17: Metal loss measurements for TP347H exposed at location TC2.

Metal loss measurements for TP347H are given in Figure 17. The metal loss measurements are very small for all exposures.

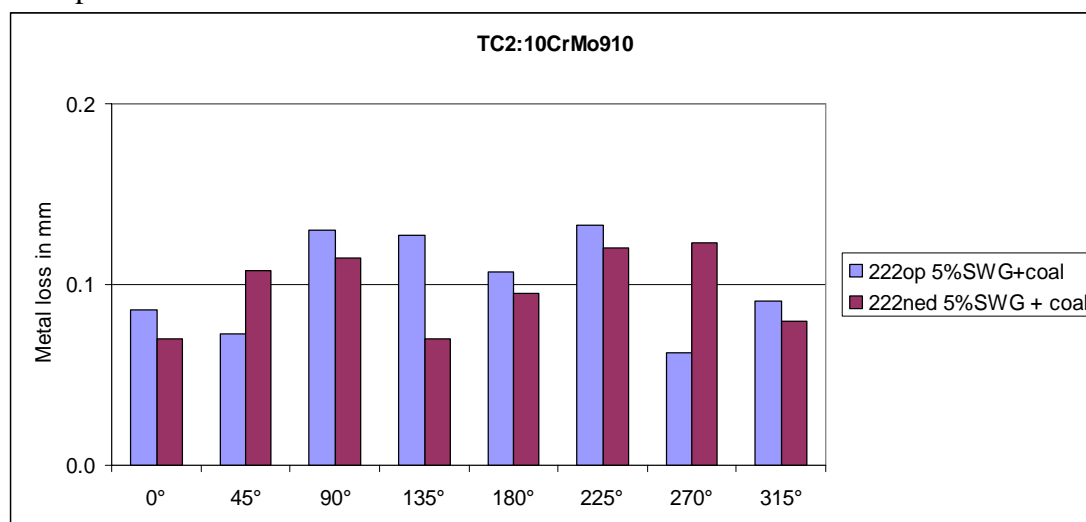
Figure 20: Metal loss measurements for 10CrMo910 exposed at location TC2.

Metal loss measurements for 10CrMo910 are given in Figure 20. The results from the coal specimens have not been undertaken.

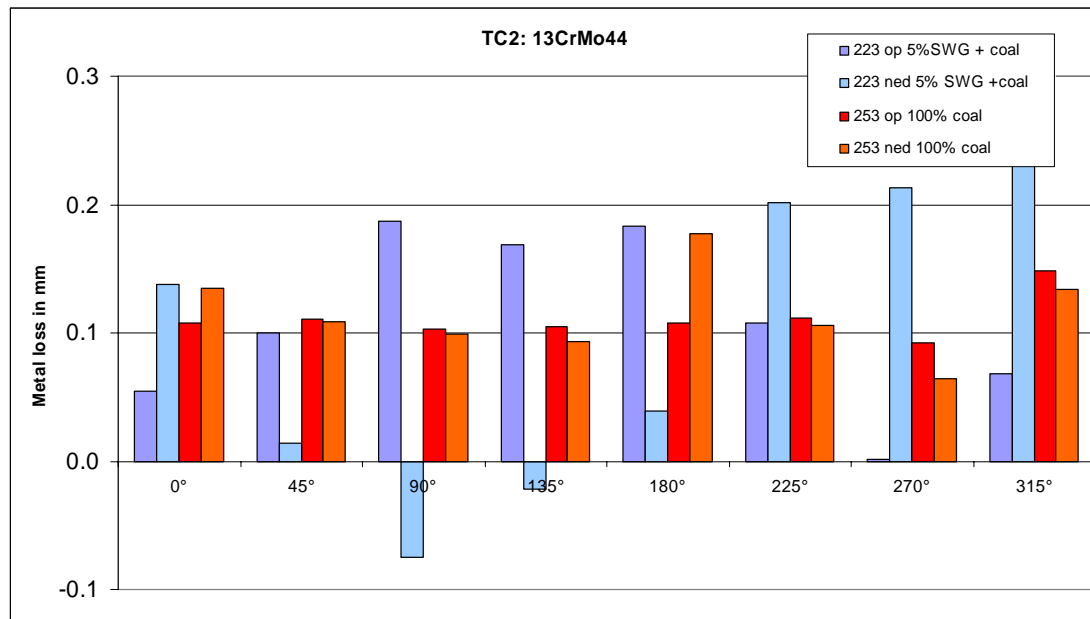
Figure 22: Metal loss measurements for 13CrMo44 exposed at location TC2.

Metal loss measurements for 13CrMo44 are given in Figure 22. The metal loss measurements are similar.

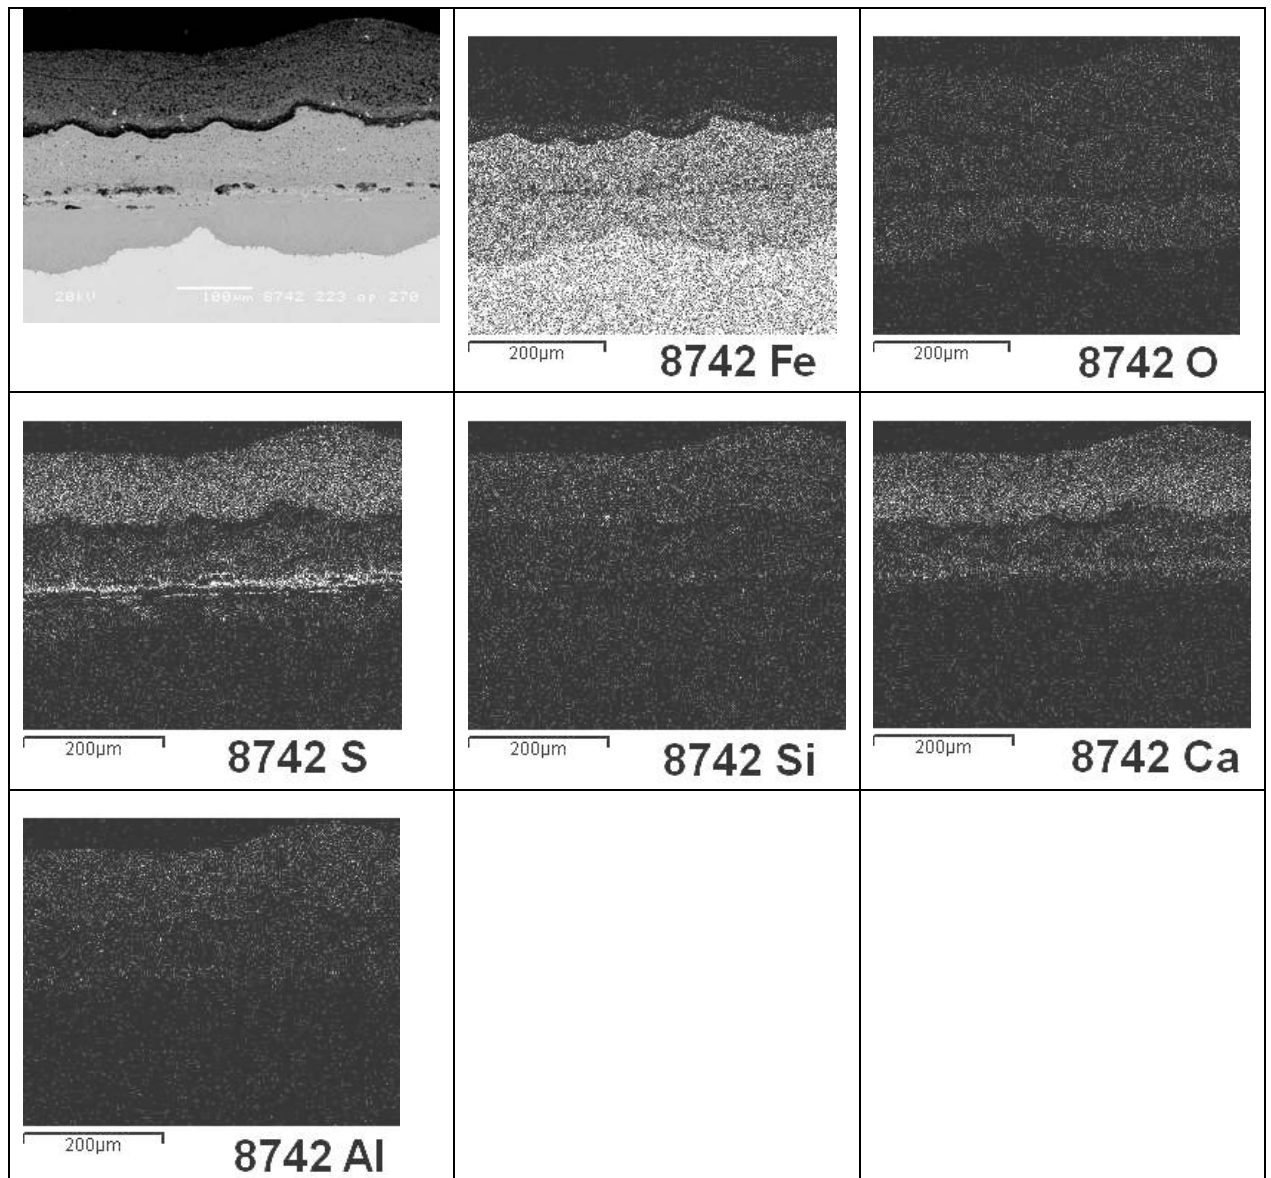
Figure 23: SEM-EDS elemental distribution map for 13CrMo44 in TC2 with 5%SWG+coal.

The deposit was primarily calcium sulphate with particles of silicon and aluminium (Figure 23). The oxide was a duplex oxide where the outer part of the oxide contained more deposit components. The original metal surface is shown where there is FeS present.

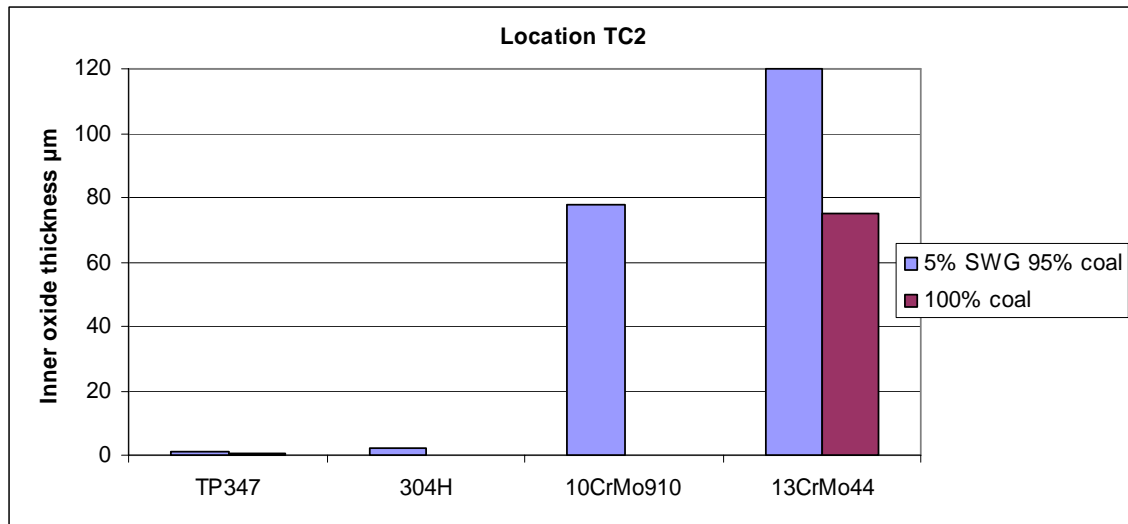
Figure 27: Inner fireside oxide thickness for specimens at location TC2.

The thickness of inner oxides is shown in Figure 27. Here the oxide thickness is similar for TP347H in both fuel conditions and is lower for 13CrMo44 for 100% coal. Although the metal loss measurements are higher, they reflect the same trend where 13CrMo44 has the greatest metal loss and the austenitic steels have the lowest metal loss.
