Long Term test Burn of switch-grass co-fired with coal at OGS.

Corrosion and deposit tests.

Doc. no. 277766
Project no. T012618.12

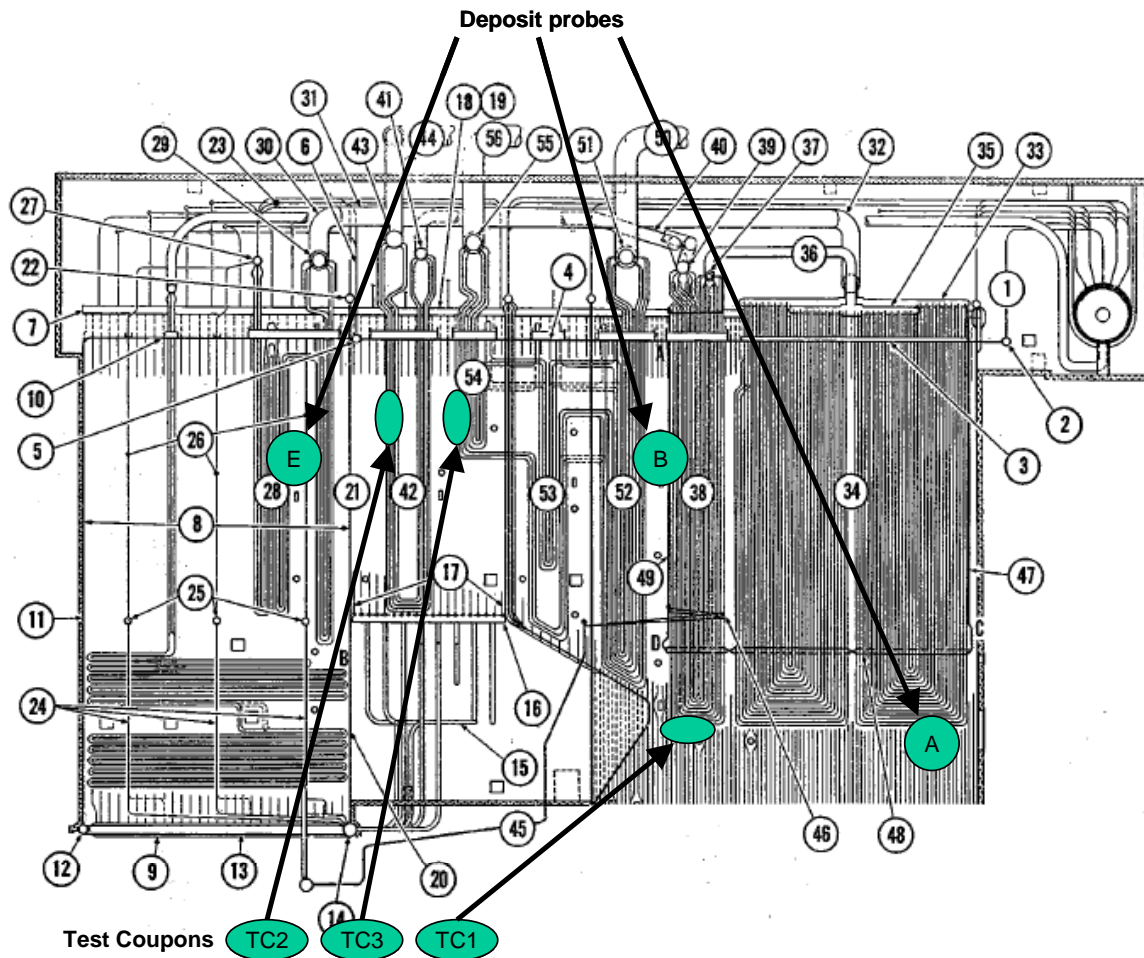
Figure 2: Locations for test coupons and deposit probes.

The RH (marked as no. 54 in Figure 2) consists of 165 bundle tubes. Original diameter (OD) and wall thickness (wt) of the tubes in TC3 area were 2.5" x 0.188".

The SHF (marked as no. 42 in Figure 2) consists of 165 panel bundle tubes. Original diameter (OD) and wall thickness (wt) of the tubes in the TC2 area was 1.88" x 0.2".

SHP (marked as no. 38 in Figure 2) consists of 41 panel bundle tubes. Original diameter (OD) and wall thickness (wt) of the tubes in the TC1 area was 2.13" x 0.3".
